**AMHARA NATIONAL REGIONAL STATE
WATER ,IRRIGATION AND ENERGY BUREAU
(BWIE))**

**GEOLOGICAL & GEOTECHNICAL
FESIBILITY STUDY
OF
AWAJO INTAKE IRRIGATION PROJECT
VOLUME II: ENGINEERING GEOLOGY**

Amhara National Regional State
Water, Irrigation and Energy Bureau
(BOWRD)
Feasibility Study and Detail Design
Of
Awajo Diversion/Intake Small-Scale Irrigation Project
Engineering Geology
Final Report
October, 2018
Bahir Dar

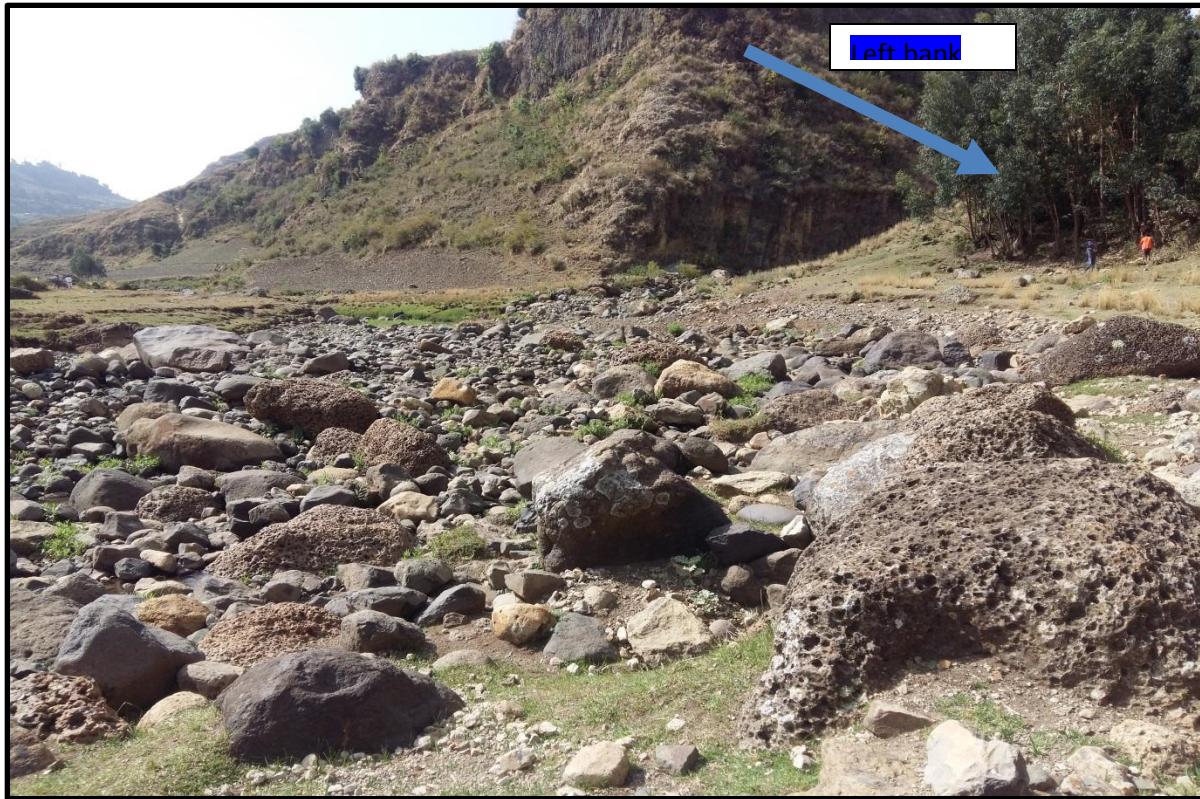
Plate 1 Left Bank of Awajo Intake

At the proposed headwork axis and immediate vicinities, the left bank forms relatively moderately to gentle slope topography. From surface observation, the bank is made up of two basic geological units. The unit is silt- sand and aphanitic basalt. For geotechnical purpose, there are two distinct layers observed at the bank. These are top silt sand deposit and underlain massive basalt rock. The slope and peak areas of the bank are covered by the silt sand deposit material. This top unit has thickness ranges of 1m to 1.5m, decreasing towards the bank foot. It is weak and loose horizon. It is flood plain deposit having gray- brown color. It has stiff consistency and dry moisture content. The bank is now affected by flood erosion that active eroded surfaces are visible. So, it is necessary to provide some bank protection structures to prevent ongoing bank erosion.

- At the proposed headwork site, the bedrock is expected at a reasonable depth (2 to 2.5m). The bed rock has sufficient bearing capacity to support such proposed intake structure. Hence the structure can be founded on the basaltic bedrock.
- During the site investigation the actual depth of this deposit material thick varies from center to banks and more than 2m diameter size boulder material deposited with active river bed. So that, with active stream bed 2.5, right bank 1.5 to 2m, left bank 1 to 1.5m have this deposited material thickness and below this deposit layer basaltic rocks are exposed. Due to this the cutoff trench should be lies on this basaltic rock accordingly the overburden deposit thickness.
- The left bank of Awajo River is characterized by erodible clay soil. It is now affected by flood erosion. It is necessary to provide bank protection work.

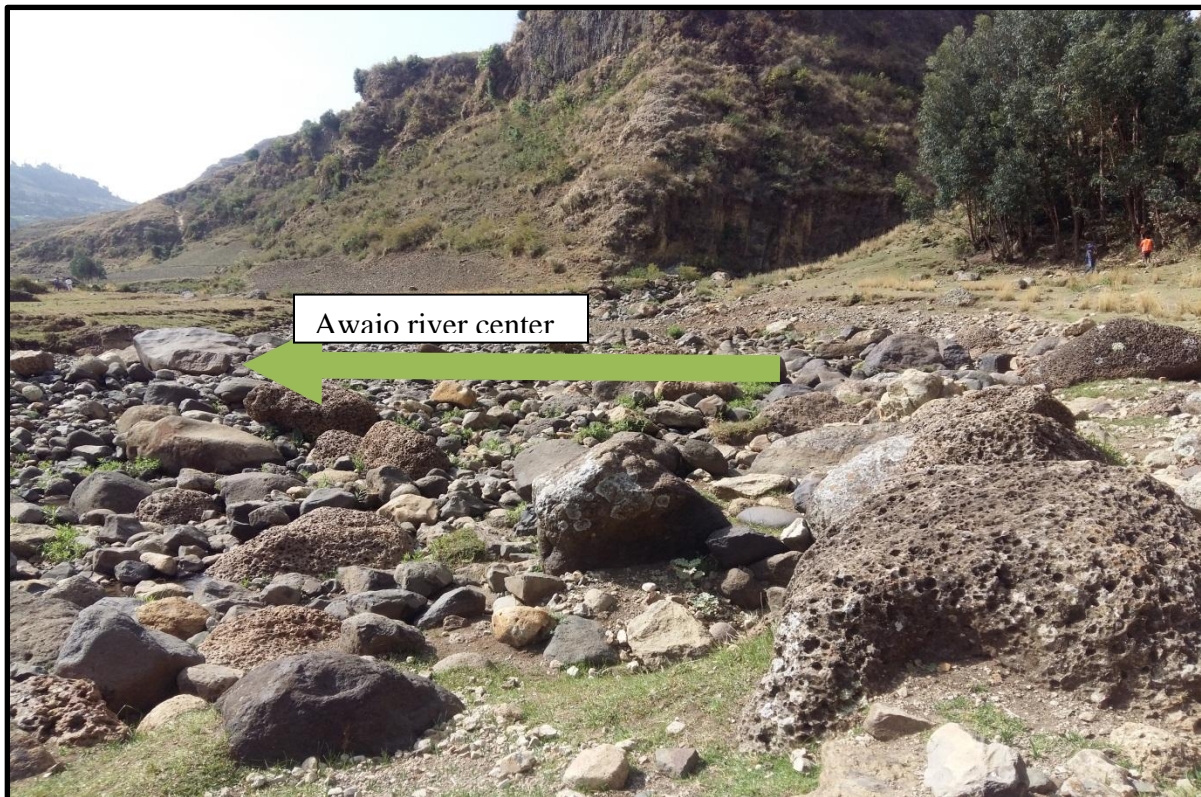
Plate 2 Awajo Intake River Center

At the proposed headwork site the stream bed or course is well defined, nearly straight, and shows rough surface due to recent sediment accumulations and undulating appearance of bedrock outcrops. Along the intake axis, the bed is made up of two basically different geologic materials, as seen from surface observation. These are **recently deposited alluvial coarse grained sediments**, and **underling bedrock**.

The central and left areas of the bed are totally covered with the alluvial deposits. The bedrock is totally covered with the sediments at the central and left areas of the stream bed. The alluvial sediment observed at the center, left and right beds are composed of silt-sand with significant amount of gravel, boulder and cobbles. It is loose, dry (at the time of study) and easily workable. From surface geological understanding of the area, the thickness of this sediment is expected in the range 2 to 2.5m. This coarser sediment is believed to be underlain by the bedrock extension that exposed at the right bed which is clearly observed in the downstream beds. On the other hand, the bedrock found at stream beds bed is affected by slight degree of weathering and

erratically oriented joints. The foundation of the proposed intake structure; therefore, can be lie on the bedrock after removing the top 2m to 2.5m deposits of silt sand at left side. In addition to this, the foundation of the bed bar (if proposed), along the axis should lie on the bedrock, after excavating the top alluvial deposit covering the center, and left bed of the river.

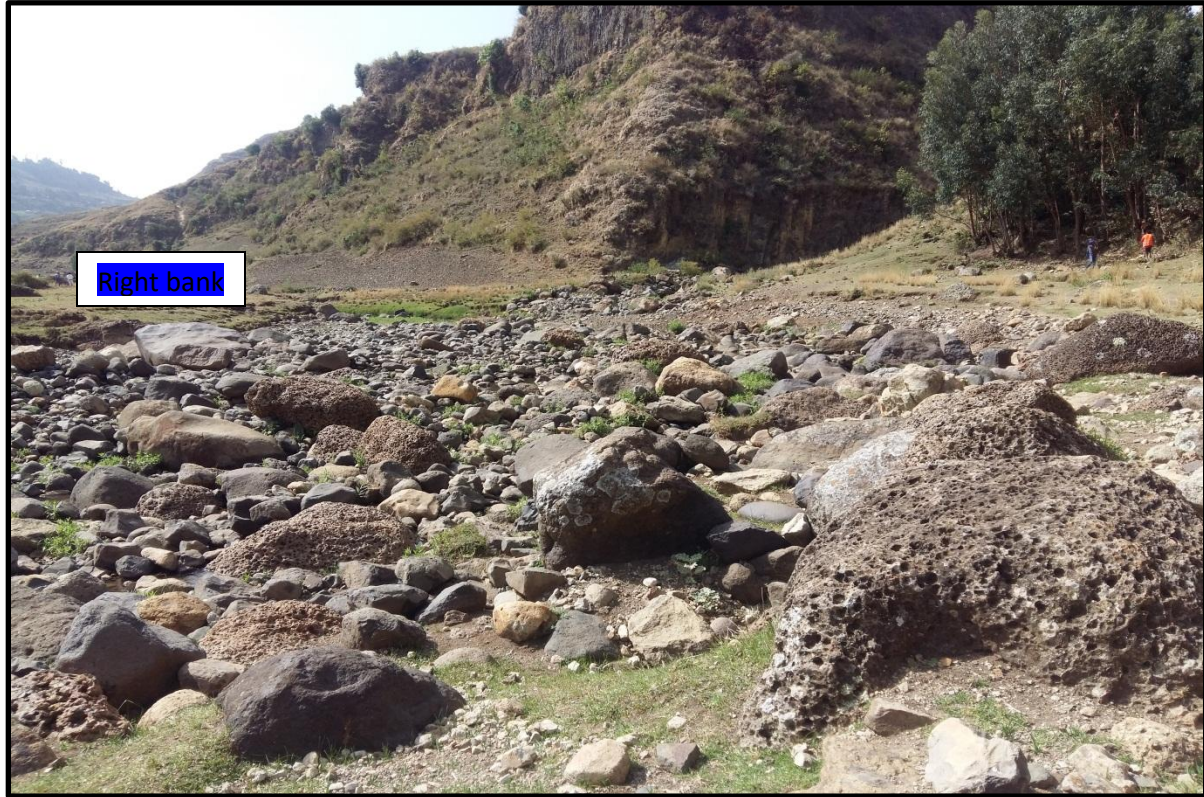
Plate 3 Right Banks of Awajo River

At the proposed headwork axis and immediate vicinities, the right bank forms relatively moderately to gentle slope topography. From surface observation, the bank is made up of two basic geological units. The unit is silt- sand and aphanatic basalt. For geotechnical purpose, there are two distinct layers observed at the bank. These are top silt sand deposit and underlain massive basalt rock. The slope and peak areas of the bank are covered by the silt sand deposit material. This top unit has thickness ranges of 1.5m to 2m, decreasing towards the bank foot. It is weak and loose horizon. It is flood plain deposit having gray- brown color. It has stiff consistency and dry moisture content. The bank is now affected by flood erosion that active

eroded surfaces are visible. So, it is necessary to provide some bank protection structures to prevent ongoing bank erosion.
