**The Federal Democratic Republic of Ethiopia
Regional State of Tigray Bureau of Water
Resource Development**

**Fiyaye Irrigational Diversion Project
Report on Fiyaye Feasibility Watershed Management
(South Eastern zone, Hintallo Wejerat Wereda)
(Final Report)**

Consultant: Tigray Water Works Study, Design and Supervision Enterprise

April, 2018

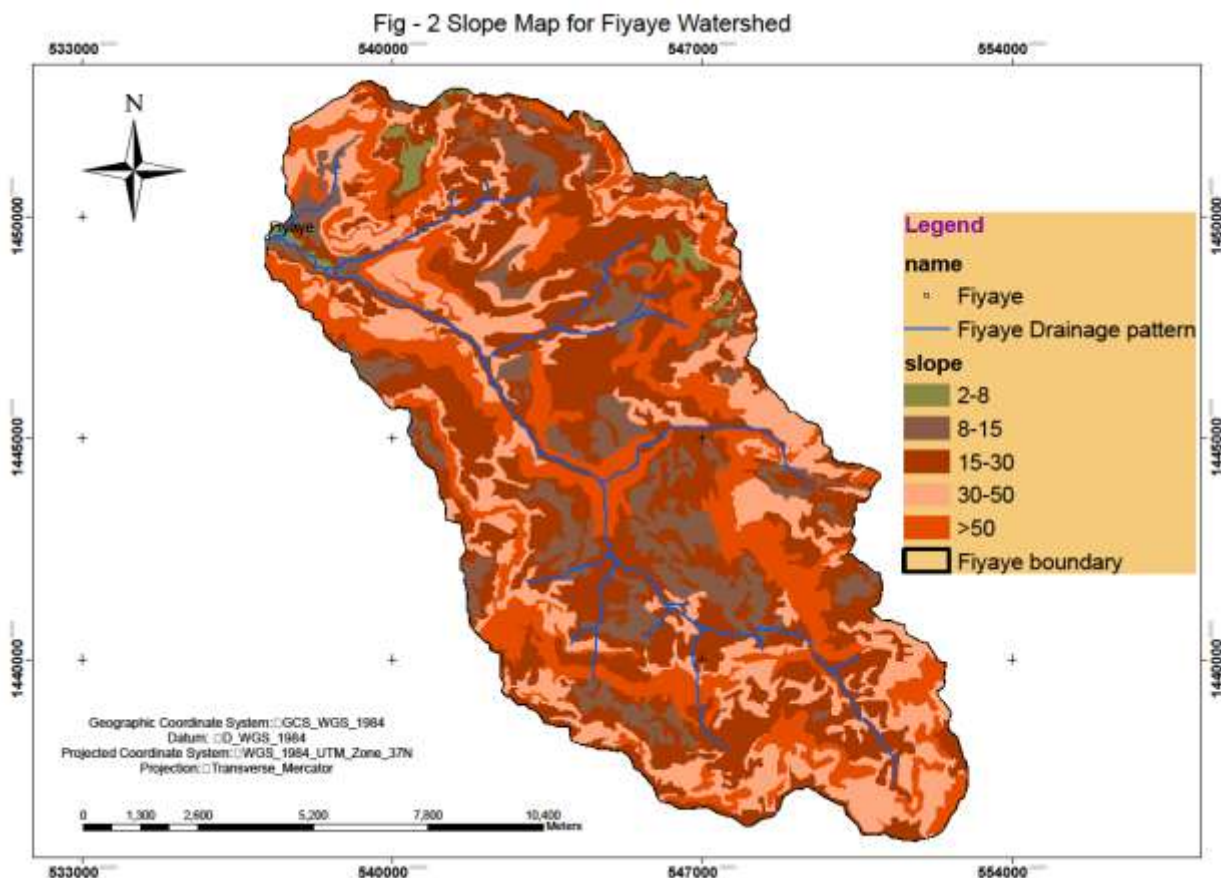
Figure 3 Slope Map for Fiyaye watershed

Topography refers to the distribution and arrangement of the physical features of the area. In this large watershed, very steep sloped to gentle slope is naturally placed to affect hydrological, biological and socio economical aspect of the catchment. Past deforestation and overgrazing practices have caused to have bare land on some steeper parts. The dominant topography in this watershed is moderately steep terrain. Such topographic feature is commonly found at the upper and middle part of the watershed. It covers 39.10% of the total catchment area. The steep topographies that are commonly found at the upper and the periphery of the

watershed occupy 24.71% of the total area. It is commonly used as cultivated land and free grazing lands. The sloping landscapes are largely found at the lower and middle part of the watershed that is commonly used as cultivated lands and homesteads. Such topographical feature covers 12.21% of the total area.

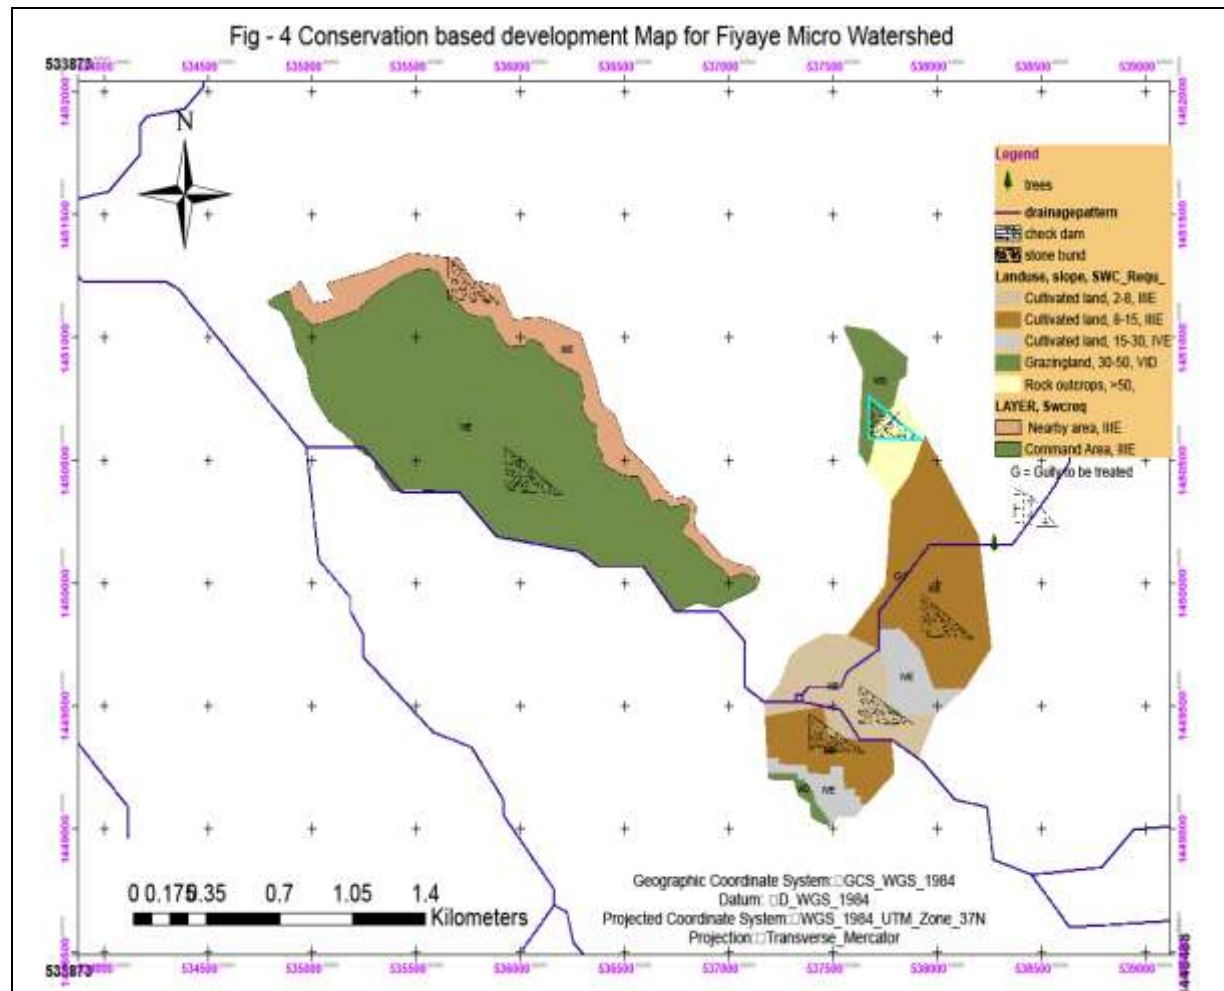
Figure 5 Conservation based Development map for Fiyaye Micro Watershed

For the specific description and cost of the overall conservation measures to be applied on this watershed area are described in the next title of watershed development cost

The erosion hazard of the micro watershed has been described based on the land capability classification of the land uses. The Soil conservation requirement classes in an increasing order starting from roman number one up to eight is sensitive to soil erosion and first priority order will be given for the larger class except for number five as shown in the development map and land capability classification table.

Therefore to reduce the destructive role of the flood transported materials and to minimize soil erosion and gully expansion, stone check dams or gabion check dams and gully side plantation are recommended. These gullies to be treated are shown in the development map of the watershed.
